NAVORD REPORT 3670

A STUDY OF THE EFFECTS OF STATIC ELECTRICITY ON LOW INPUT ENERGY
ELECTRIC INITIATORS OF THE CARBON BRIDGE TYPE

5 AUGUST 1954

U. S. NAVAL ORDNANCE LABORATORY
WHITE OAK, MARYLAND

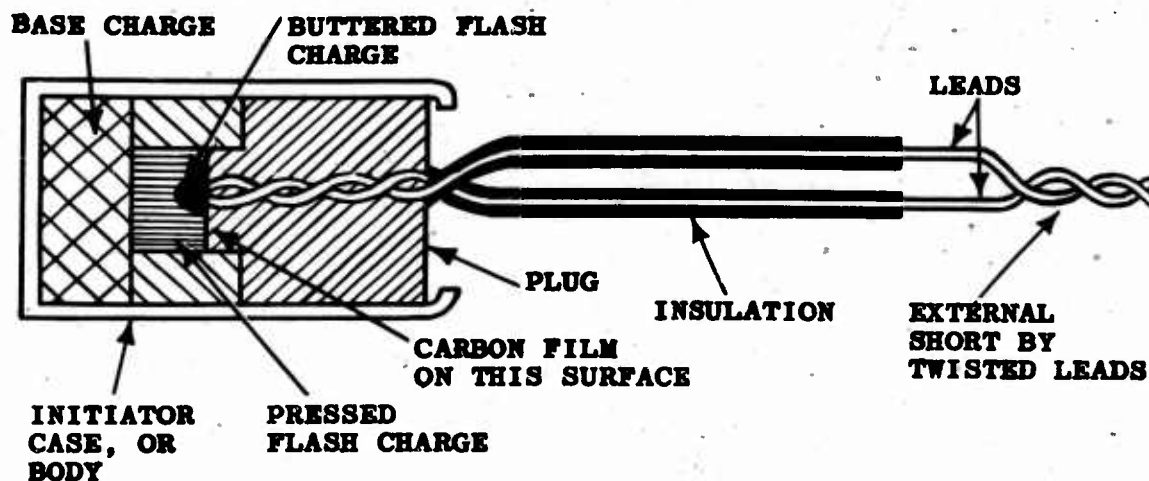
FIG. 11 PHYSICAL ARRANGEMENT OF A CARBON BRIDGE INITIATOR

41. An understanding of the various ways in which electrical energy can induce an explosion will provide a logical basis for the application of the fundamental principles of safe handling. Figure 11 is a schematic representation of a carbon bridge electro-explosive device. In normal use, the primer is fired by applying electrical energy of suitable properties to the leads from which has been removed the external electrical short.

The circuit is completed through the carbon film on the face of the plug. The electrical energy is dissipated in the carbon film, heating it enough to cause ignition of the flash charge.

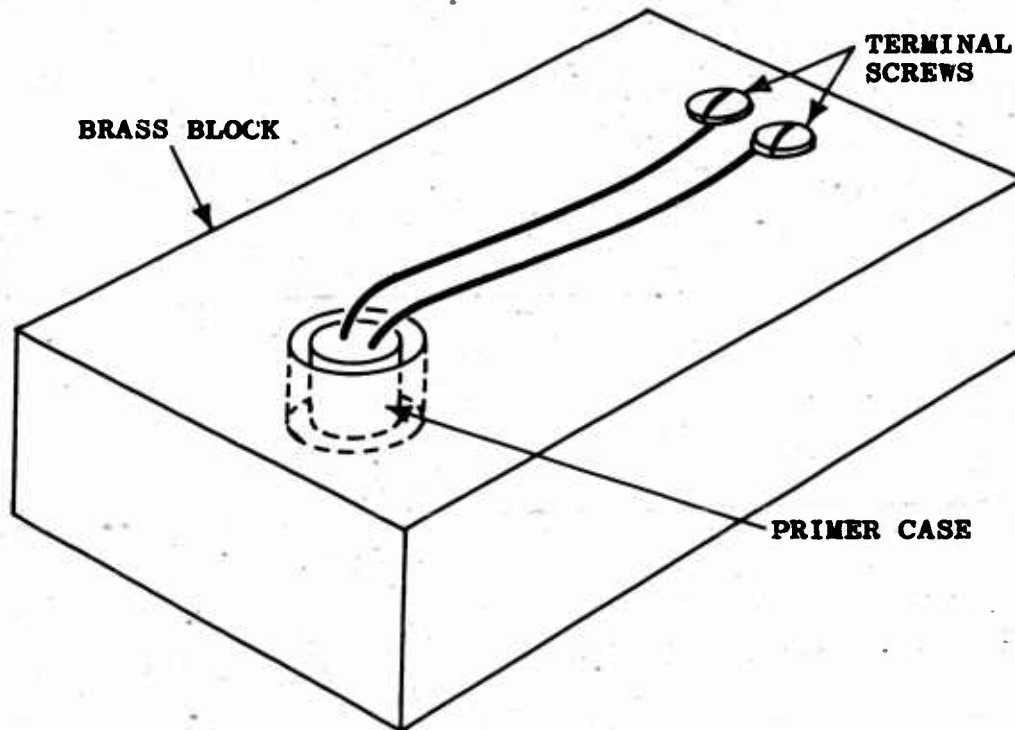
FIG. 12 SETUP TO DEMONSTRATE SENSITIVITY OF INITIATOR WITH GROUNDED CASE AND LEADS TO ENERGY PULSES

45. It would seem that to cope with any of the mechanisms listed in the previous paragraphs would require only that the leads and case be electrically shorted together. However, with lead wire devices, it is difficult to short the leads and case together effectively under pulse discharge conditions. To prove this, a setup was made at the Naval Ordnance Laboratory to determine the effectiveness of such

a shorting system. Figure 12 shows the method of mounting the primers for this test. In this case the insulated length of lead was about 4 inches. The bare lead ends were clamped to the brass blocks by two roundhead brass screws. The explosive unit case was set in the drilled hole below

the surface of the block. The block was set on a grounded support, as in Figure 13 and a 50 $\mu\mu\text{fd}$ capacitor charged to 10,000 volts was discharged to the center portion of the insulated lead wires through an electrode system. Of 25 primers tested in this setup, one fired. This behavior can be attributed to the fact that under pulse or transient conditions a large potential gradient can be established momentarily on a conductor, the gradient propagating along the conductor in the manner of a micro-wave transmission line. Under this condition the primer initiation might be a normal bridge firing or a lead-to-case breakdown.

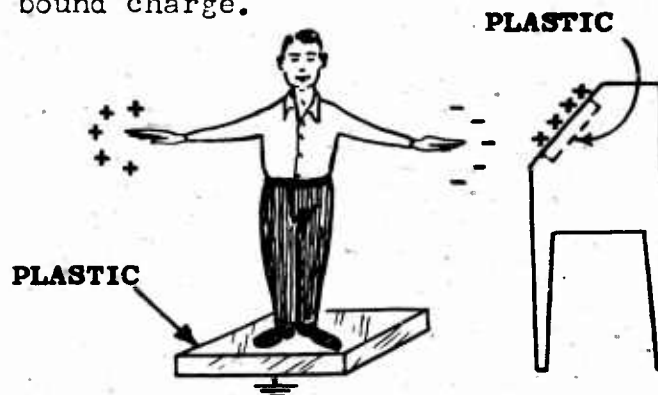
FIG. 15 CAPACITIVE INDUCTION

58. In addition to the accumulation of a charge by friction and by transfer, a charge can be formed by induction. The operator need not touch a bound charge but instead approach fairly closely to become in turn charged. As in Figure 15, electrons will move toward or away from the portion of the body closest to the bound charge in an attempt to neutralize the field of the bound charge. The displacement of electrons within the operator's body will cause a charge distribution to form on portions of the body farther away from the bound charge. This distribution will be of the same polarity as that of the bound charge.

59. There has been reported an instance of initiation of a carbon bridge primer which can be attributed to capacitive induction. The circumstances were said to be as follows:
